# HITACHI

## HA8000V シリーズ

### Service Pack for HA8000V (SPH)

## Readme

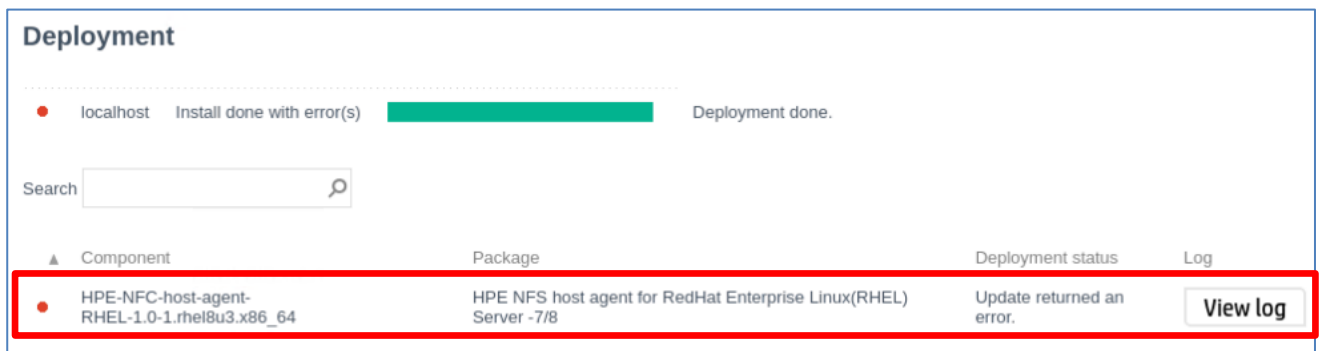
エラーが発生したパッケージは、赤丸(赤枠内)で表示されます。

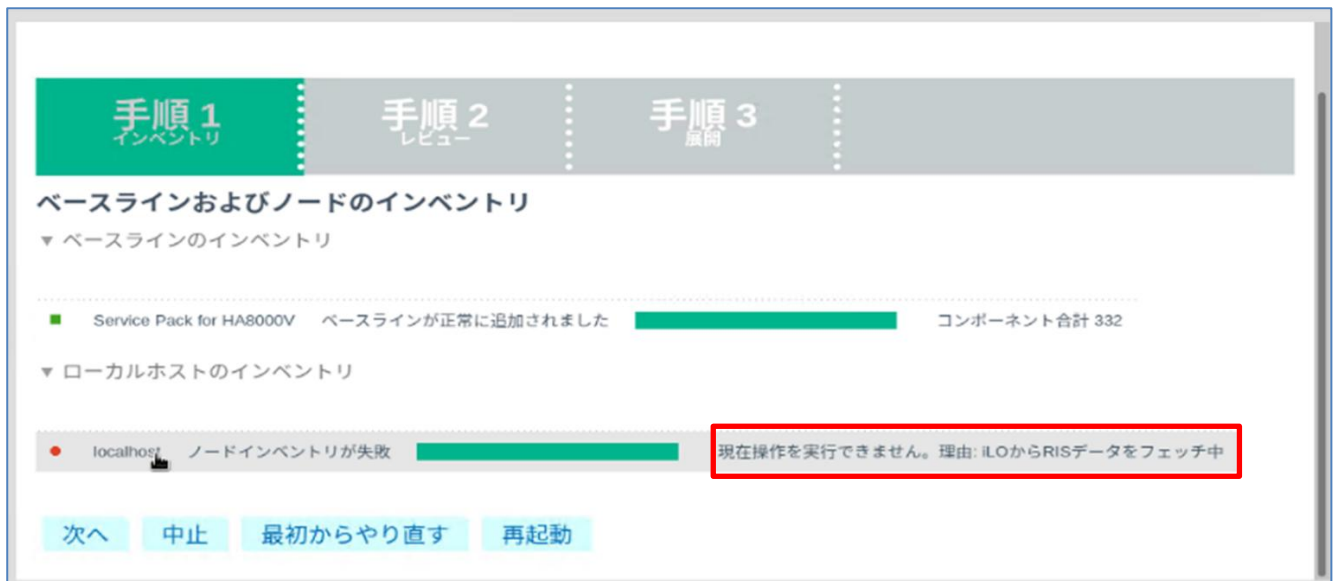
## 【インベントリ失敗時の表示例】

iLO の状態により、まれに情報取得できないことがあり、以下に示すようにインベントリに失敗します。

SUM を再実行しても本エラーが解消されない場合は、下記のいずれかの手順を実施してください。

- iLO の再起動（リセット）を実施してください。詳細は『iLO 7 x.xx ユーザーガイド』(※)の「iLO の再起動（リセット）」を参照してください。『iLO 7 x.xx ユーザーガイド』は、「[日立アドバンスドサーバ HA8000V シリーズ ホームページ](#)」に掲載されている「製品マニュアル」よりダウンロードしてください。
- オンラインアップデート(OS 稼働中のアップデート)の場合、装置の再起動を実施してください。
- 装置の給電を停止(電源ケーブルの抜去や UPS の出力停止等)後、10 秒待った後に給電を再開してください。
