# HITACHI

## HA8000V シリーズ

### Service Pack for HA8000V (SPH)

## Readme

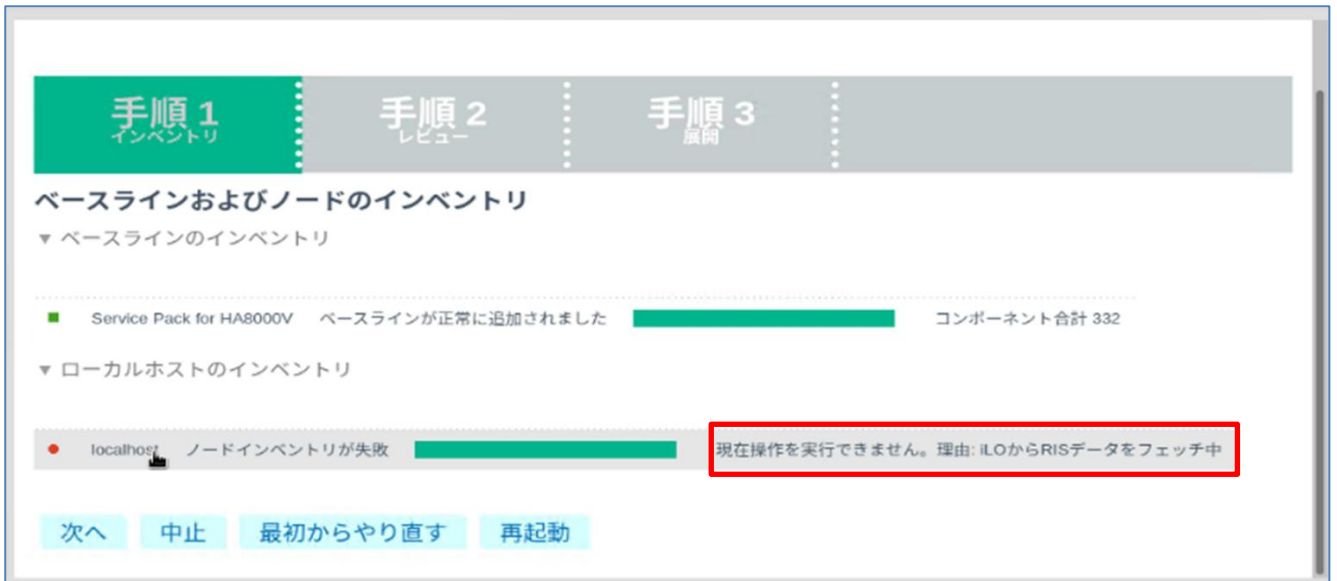
## 【インベントリ失敗時の表示例】

iLO の状態により、まれに情報取得できないことがあり、以下に示すようにインベントリに失敗します。

SUM を再実行しても本エラーが解消されない場合は、下記のいずれかの手順を実施してください。

- iLO の再起動（リセット）を実施してください。詳細は『iLO 7 x.xx ユーザーガイド』（※）の「iLO の再起動（リセット）」を参照してください。『iLO 7 x.xx ユーザーガイド』は、「[日立アドバンスドサーバ HA8000V シリーズ ホームページ](#)」に掲載されている「製品マニュアル」よりダウンロードしてください。
- オンラインアップデート(OS 稼働中のアップデート)の場合、装置の再起動を実施してください。
- 装置の給電を停止(電源ケーブルの抜去や UPS の出力停止等)後、10 秒待った後に給電を再開してください。
