# HITACHI

## HA8000V シリーズ

### Service Pack for HA8000V (SPH)

## Readme

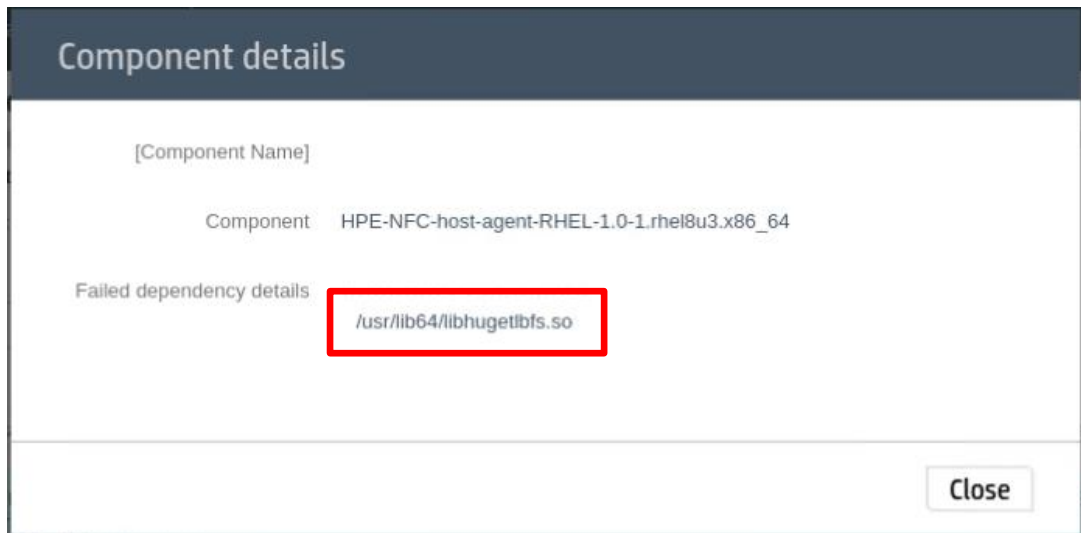
上記赤枠内の赤丸をダブルクリックすると次のダイアログが表示され、“Failed dependency details”として、インストールが必要となるファイル/ライブラリが表示されます。(赤枠内)

上記の例では、インストールが必要となるファイル/ライブラリとして、“libhugetlbfs.so”を示しています。

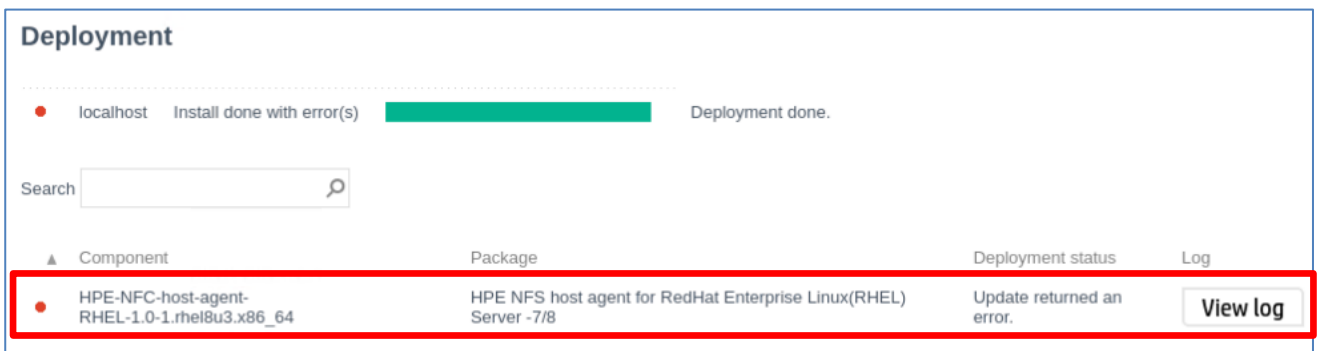
エラーが発生したパッケージは、赤丸(赤枠内)で表示されます。

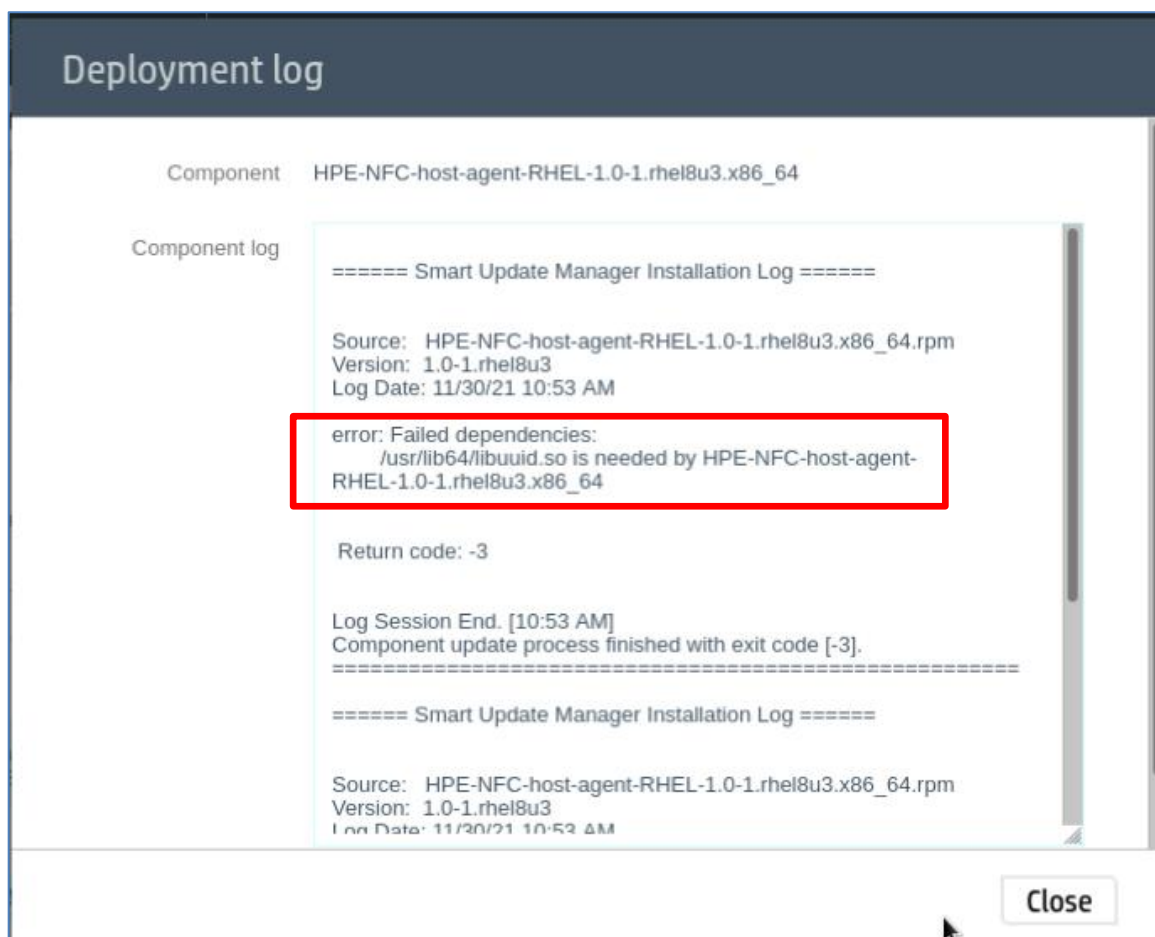
上記赤枠内の“View log”をクリックすると次のダイアログが表示され、“error: Failed dependencies:”として、インストールが必要となるファイル/ライブラリが表示されます。(赤枠内)

上記の例では、インストールが必要となるファイル/ライブラリとして、“libuuid.so”を示しています。

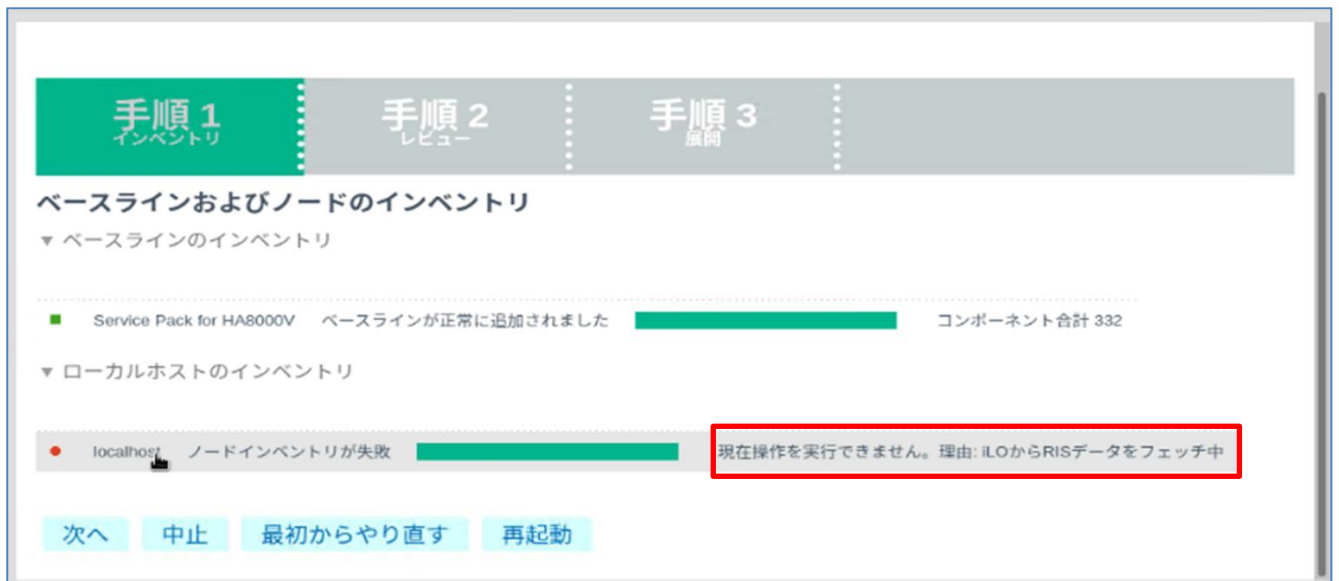
## 【インベントリ失敗時の表示例】

iLO の状態により、まれに情報取得できないことがあり、以下に示すようにインベントリに失敗します。

SUM を再実行しても本エラーが解消されない場合は、下記のいずれかの手順を実施してください。

- iLO の再起動（リセット）を実施してください。詳細は『iLO 7 x.xx ユーザーガイド』（※）の「iLO の再起動（リセット）」を参照してください。『iLO 7 x.xx ユーザーガイド』は、「[日立アドバンスドサーバ HA8000V シリーズ ホームページ](#)」に掲載されている「製品マニュアル」よりダウンロードしてください。
- オンラインアップデート(OS 稼働中のアップデート)の場合、装置の再起動を実施してください。
- 装置の給電を停止(電源ケーブルの抜去や UPS の出力停止等)後、10 秒待った後に給電を再開してください。
